**RE:** 2018 Annual PCB Wipe Sampling  
Sky Valley Educational Center  
351 Short Colombia Street  
Monroe, Washington

PBS Engineering and Environmental, Inc. (PBS) performed Polychlorinated Biphenyl (PCB) surface testing for the annual monitoring program at the Sky Valley Educational Center (SVEC) located at 351 Short Columbia Street, Monroe, Washington. The following report discusses background information, methodology, findings and conclusions.

**GYM BUILDING  
CAULKING ABATEMENT PLAN**  
SKY VALLEY EDUCATIONAL CENTER

POD/LIBRARY BUILDING  
CAULKING ABATEMENT PLAN  
SKY VALLEY EDUCATIONAL CENTER

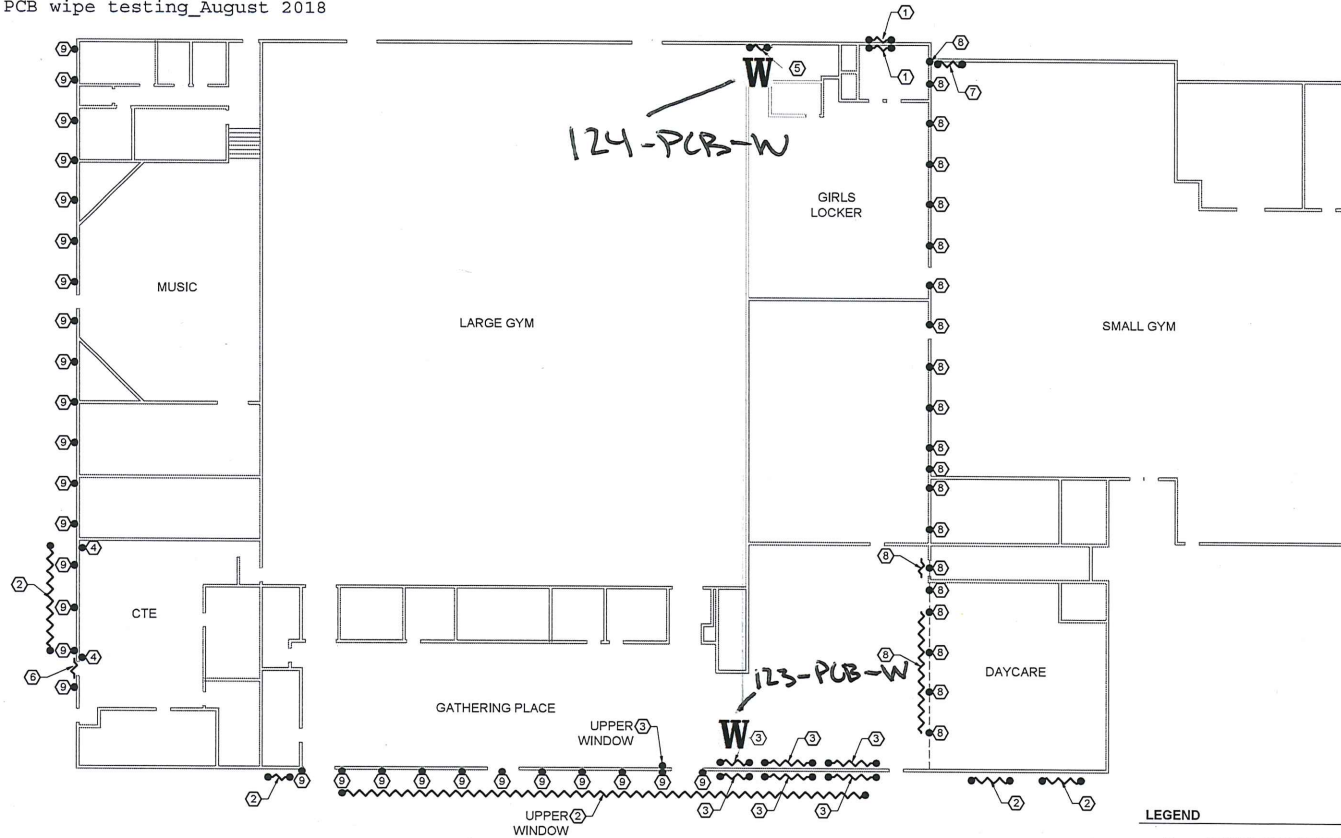
**GYM BUILDING**  
NOT TO SCALE

**W** Wipe Test Sample

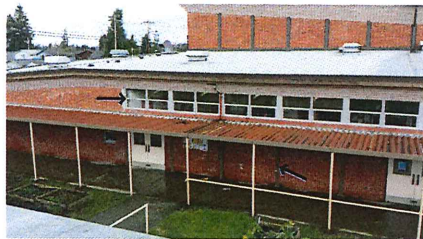
②⑤ PHOTO DETAIL

- ② REMOVE APPROX. 300 LF OF PCB-CONTAINING CAULKING ON THE EXTERIOR METAL WINDOW FRAMES ON ALL WINDOWS AT THE SOUTH AND WEST ELEVATIONS OF THE LARGE GYM BUILDING AS SHOWN. THIS INCLUDES CAULKING THAT EXISTS AROUND EACH WINDOW INFILL PANEL METAL FRAME TRANSITION ON THE WEST ELEVATION. THESE INFILL PANELS ARE CEMENT ASBESTOS BOARD.

- ④ REMOVE APPROX. 10 LF OF PCB-CONTAINING OF CAULK ON INTERIOR WINDOW FRAME VERTICALS IN THE CTE ROOM AS SHOWN.
- ⑤ REMOVE APPROX. 18 LF OF PCB-CONTAINING OF CAULK ON INTERIOR SIDE OF NORTH EXTERIOR GIRLS LOCKER ENTRY DOOR AS SHOWN.

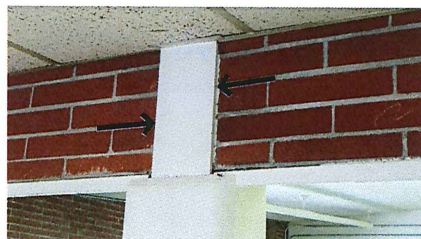
⑧ PHOTO DETAIL

- ⑧ REMOVE APPROX. 500 LF OF PCB-CONTAINING CAULKING LOCATED ON ALL VERTICAL STRUCTURAL METAL COLUMN TRANSITIONS THROUGHOUT THE EAST ELEVATION OF THE LARGE GYM AS SHOWN. THIS INCLUDES THE REMOVAL OF ALL CAULKING ON THE INTERIOR DEMISING WALL METAL BEAMS (VERTICAL AND HORIZONTAL) BETWEEN THE DAYCARE AND THE GATHERING PLACE/CAFETERIA AS SHOWN. THE CAULKING IS HEAVILY PAINTED THROUGHOUT THE WORK SCOPE AREA.

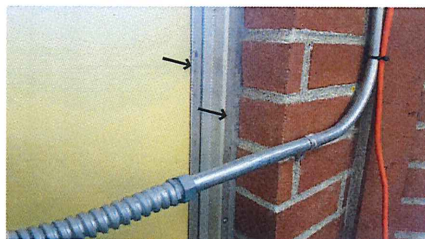
① PHOTO DETAIL

- REMOVE APPROX. 500 LF OF PCB-CONTAINING CAULKING LOCATED ON INTERIOR PERIMETER METAL WINDOW FRAME TO BRICK TRANSITION VERTICALS IN EACH OF CLASSROOMS 1-20 AS SHOWN.
- REMOVE APPROX. 1,400 LF OF PCB-CONTAINING CAULKING ON THE INTERIOR AND EXTERIOR SIDES OF THE CEMENT ASBESTOS BOARD (CAB) WINDOW INFILL PANELS. THE CAULKING FILLS THE GAP BETWEEN THE METAL WINDOW FRAME AND CAB TRANSITION IN EACH OF CLASSROOMS 1-20 AS SHOWN.
